BOMB STORE AT GLYN RHONWY, LLANBERIS

Bomb Store at Glyn Rhonwy, Llanberis

Structural Report

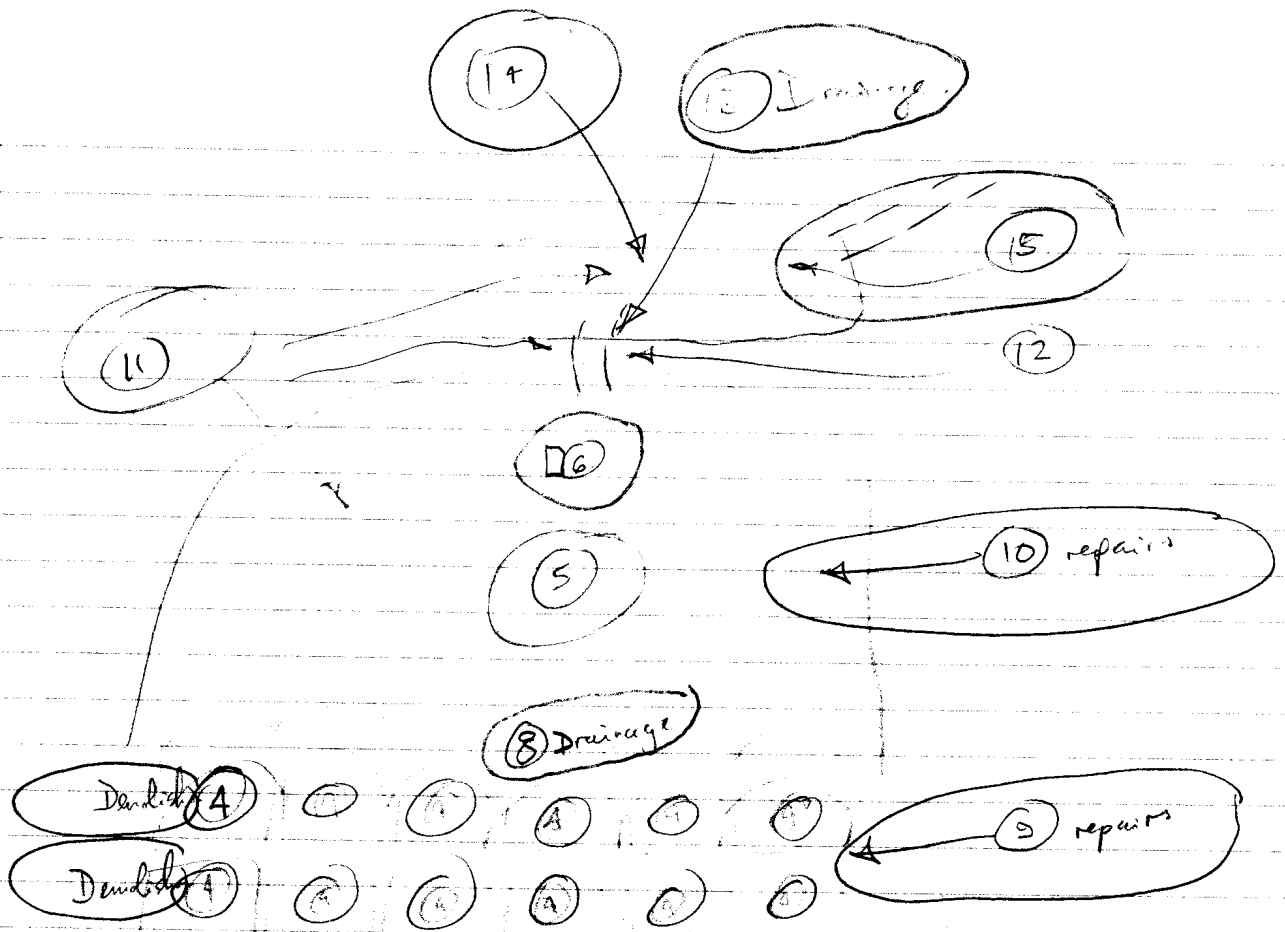
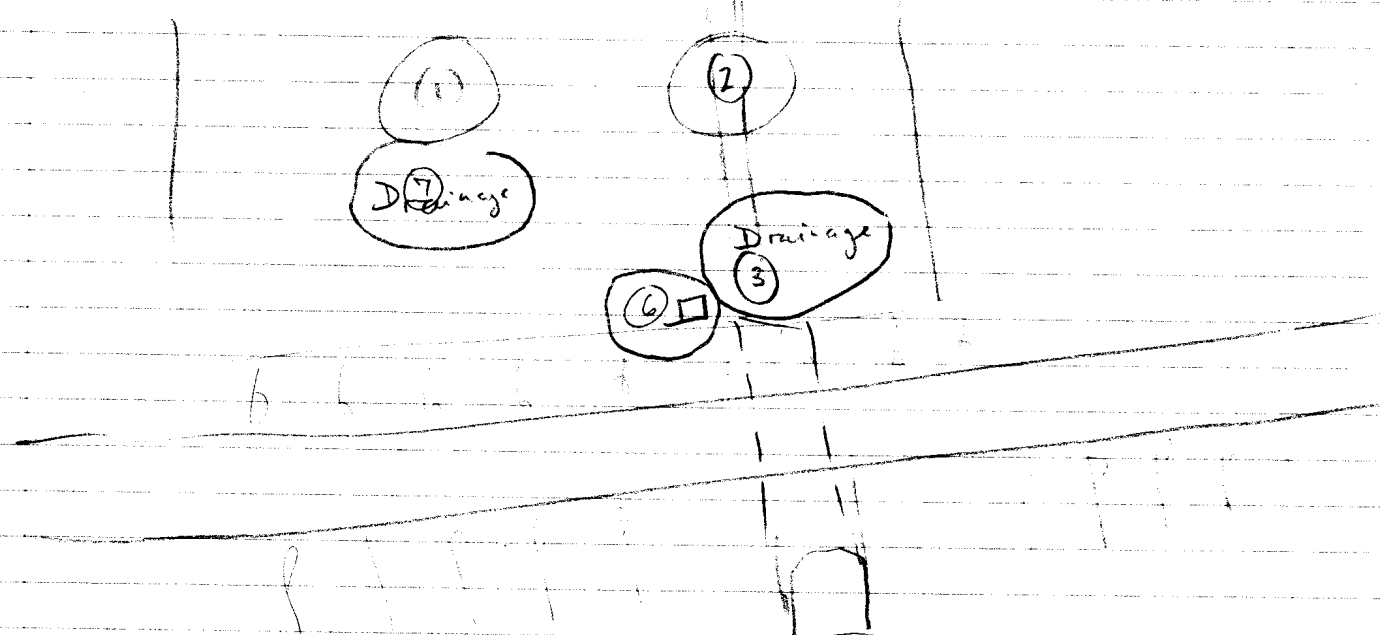
REPAIRS.
 DEMOLITION.
 DRAINAGE.
 CLIRIO.
